PRELIMINARY INVESTIGATION: BLOCK 2806 LOT 1

Area in Need of Redevelopment

Van Cleef Engineering Associates

Town of Phillipsburg, Warren County

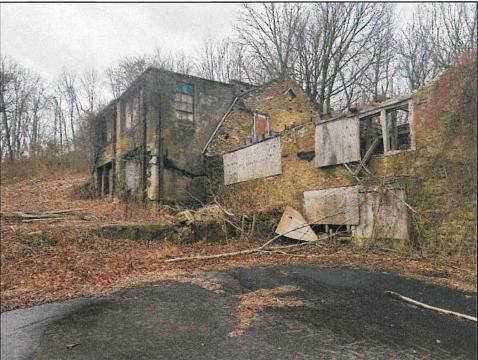
Photo 3: Typical atgrade view of the subject property's "Ice House. Note the vegetation and dilapidated state of the structure.

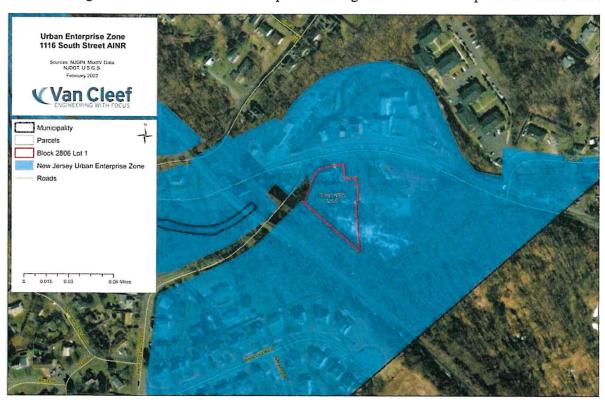
In applying this criteria, if a property is located within an Urban Enterprise Zone (UEZ), the mere fact that it is located within this designated area is "sufficient for the determination that the area is in need of redevelopment". Having gone through the proper channels to designate the UEZ and fulfilling the requirement for determining an area in need of redevelopment, the Town has indicated the subject parcel should be designated an area in need of redevelopment. The figure below shows the parcel within the UEZ.
